CHECK-OUT REPORT

PROPERTY	Flat xx, xx Lane, Hounslow, Middlesex, TW4
TYPE	2 Bedroom Apartment
DATE	1st April 2004
ON BEHALF OF	Client

DILAPIDATIONS REPORT

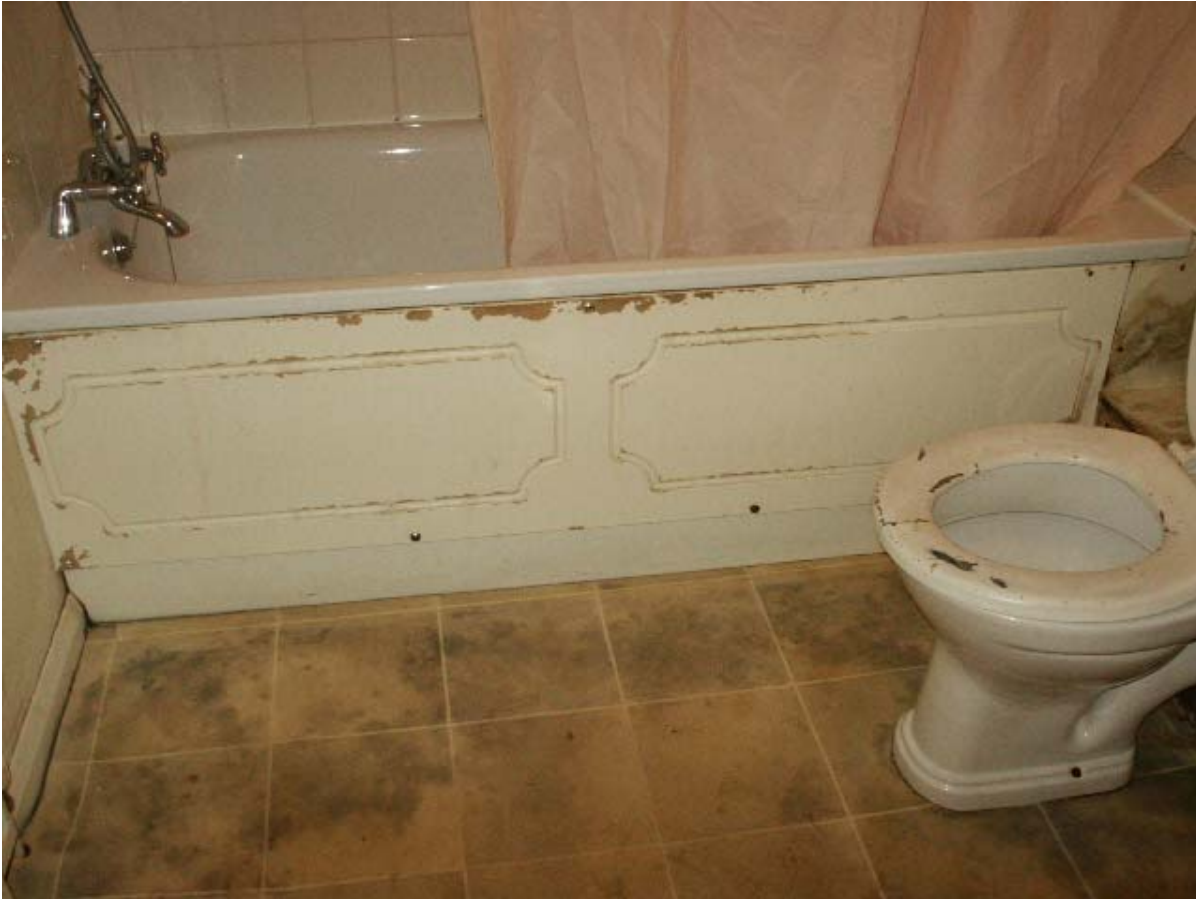
Bathroom – water damage to bath panel and floor

FLOORING	5	Flooded. Water damaged.	See notes
WOODWORK	5	Heavily water stained around toilet and edge of bath. Skirting water stained around toilet and basin; generally marked and chipped.	See notes
BATH	5	Bath panel in very poor condition.	See notes
W/C	5	Seat broken, cracked and marked.	Replacement cost
MISCELLANEOUS	5	Pink PVC shower curtain. Water marked.	No value

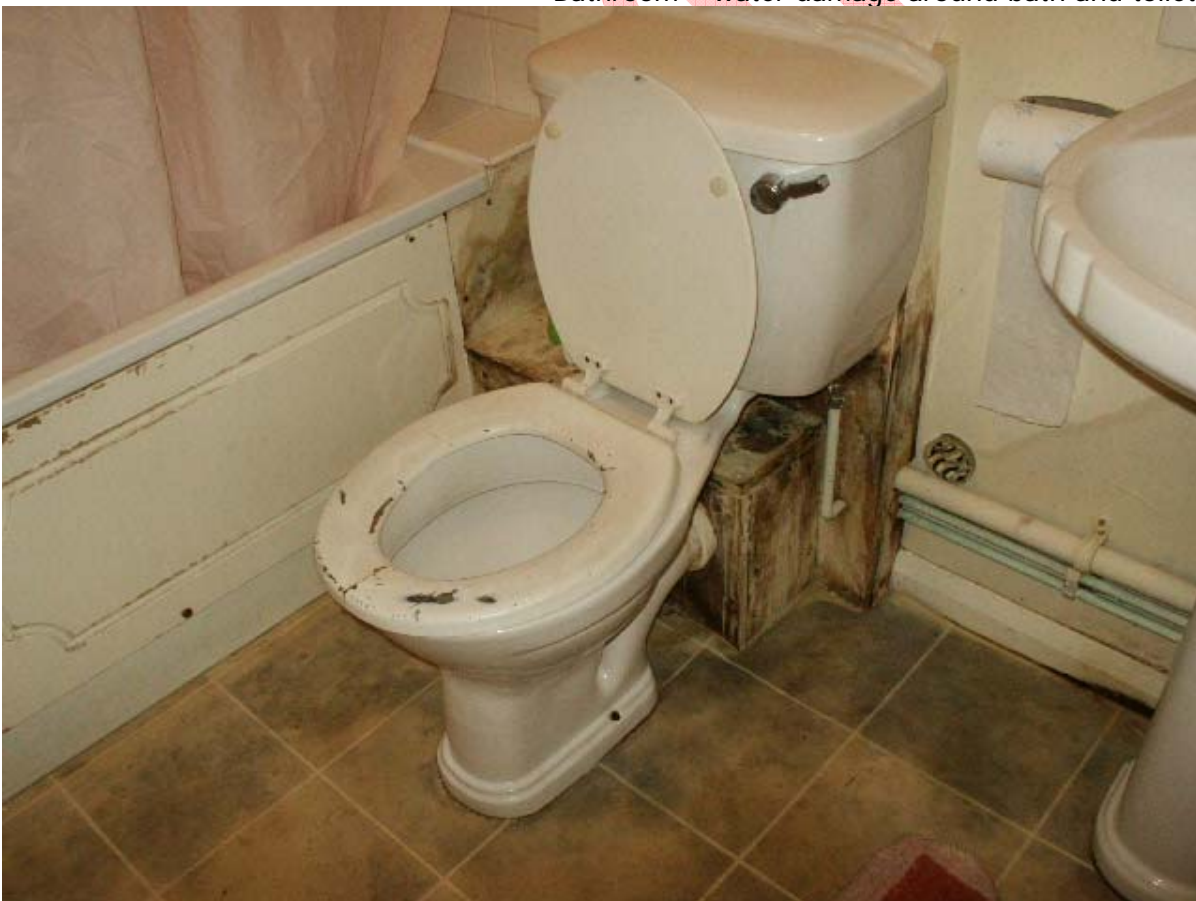
Bathroom – water damage around bath and toilet
